AATSR Performance

Dr Dave Smith

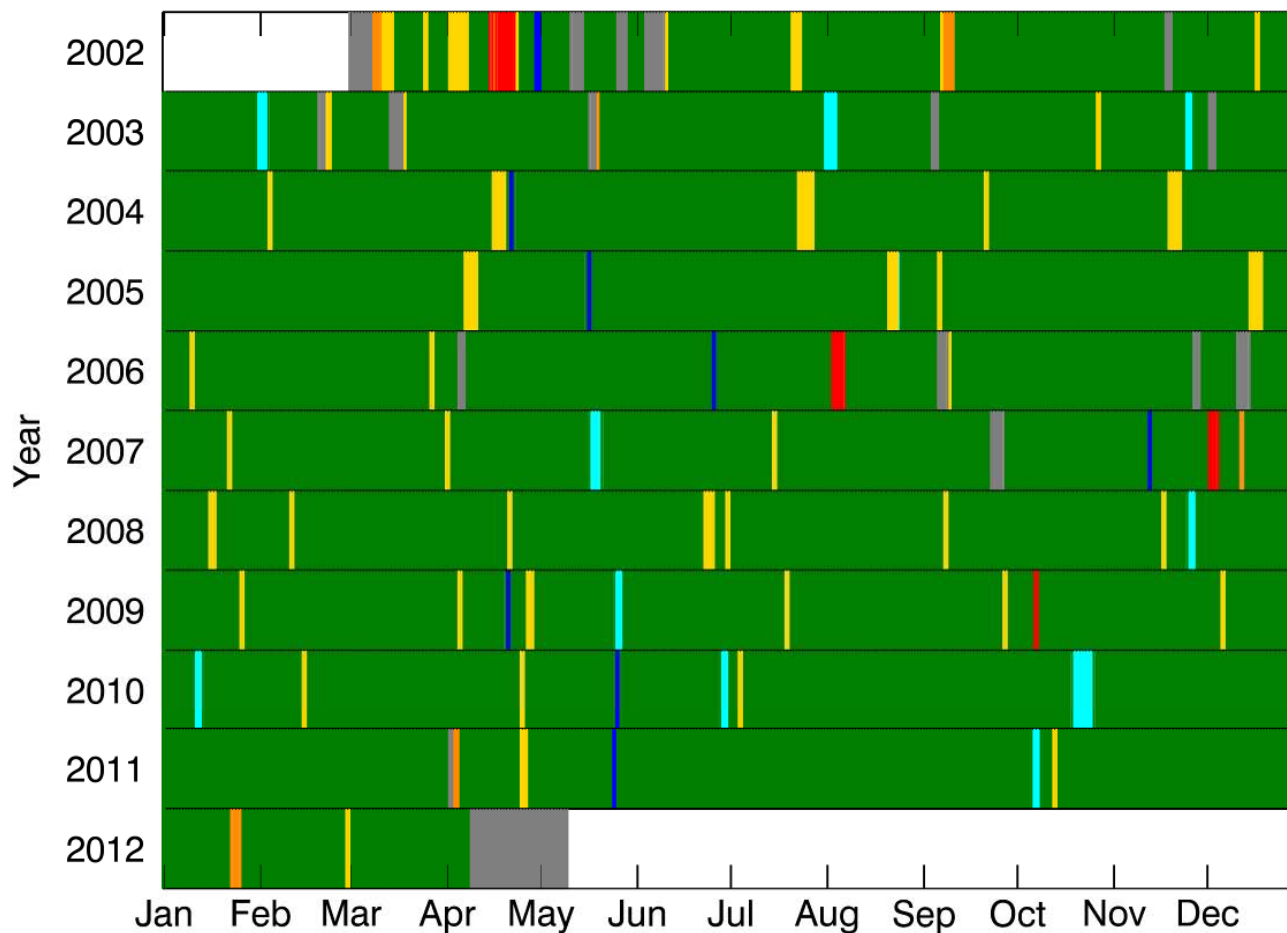
AATSR Operations Summary

- Grey – all units off
- Orange – AATSR in STANDBY or WAIT
- Amber – AATSR in HEATER or TRANSITION to HEATER
- GREEN – AATSR in MEASUREMENT mode
- CYAN – OUT-GASSING - AATSR in MEASUREMENT mode
- BLUE – BB CROSS OVER – AATSR in MEASUREMENT mode
- RED – AATSR in STANDBY/REFUSE or WAIT due to instrument anomaly

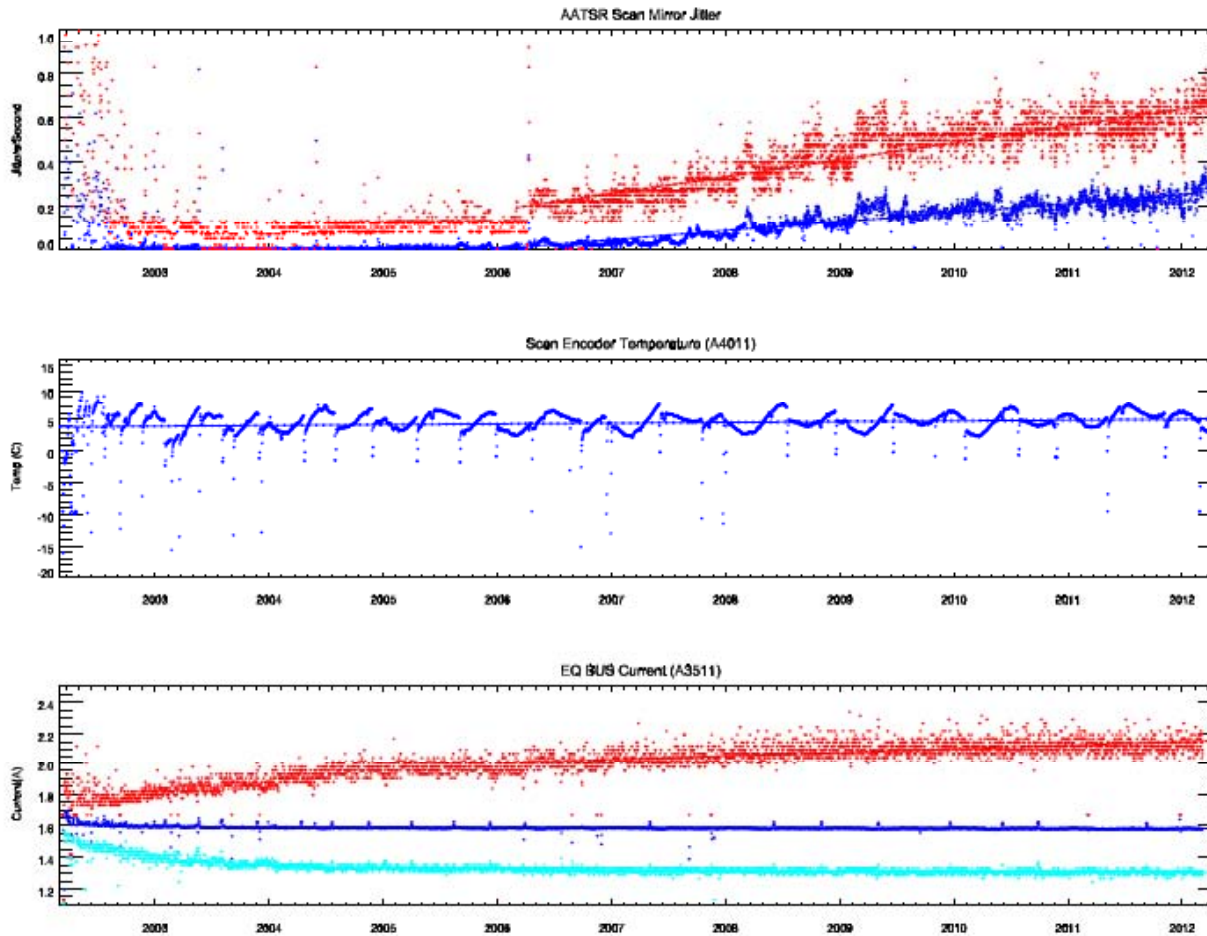
Scan Mirror Unit

Since the first switch-on, the scan mirror has completed in excess of 2.1 billion revolutions with the scan period being maintained at 150ms.

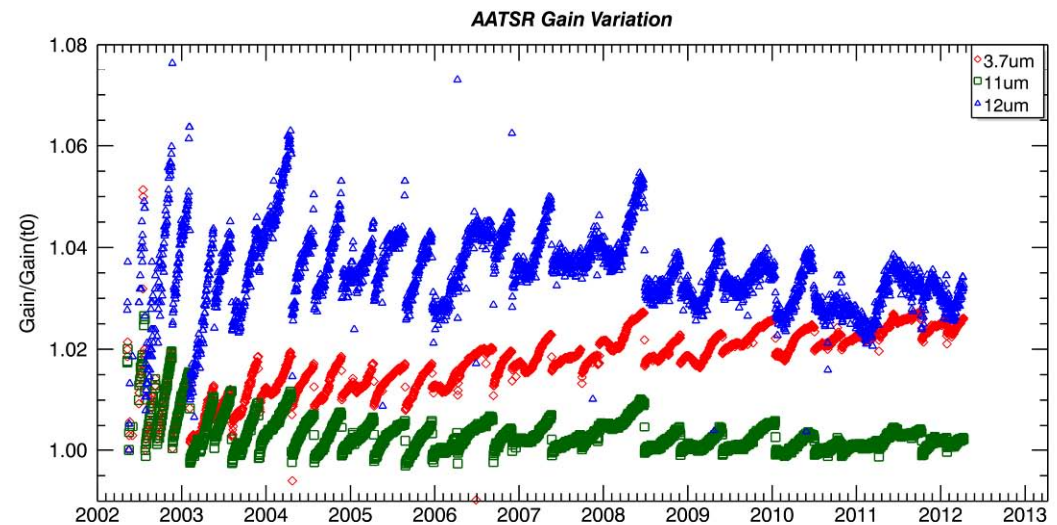
TIR Channels Performance

Closer inspection of the gain variation over the mission reveals behaviour very similar to the cooler trends.

Although the long-term mission trend has remained stable (<3% drift), the short-term variation suggests that the IR-FPA throughput was also affected by water ice contamination.

This is consistent with the build-up of molecular contamination either around the field stop or deposition on BS3

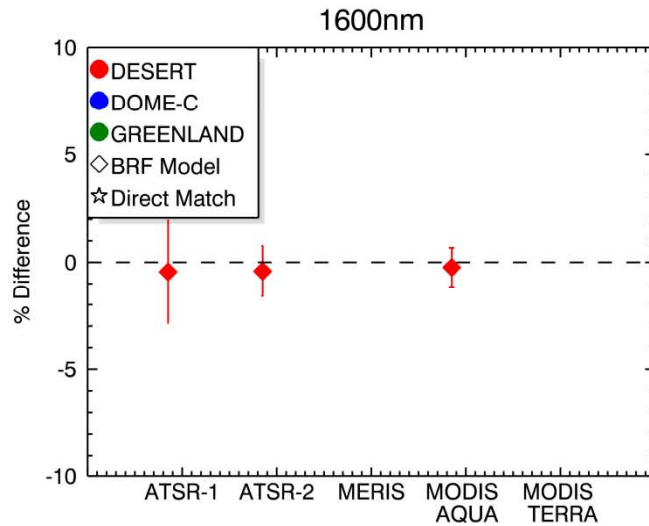
Intercomparison summary of reflectance channels Adjusted for estimated spectral errors
